BLACKSTONE RIVER BASIN
MILLBURY, MASSACHUSETTS

SINGLETARY POND DAM
MA 00144

PHASE I INSPECTION REPORT
NATIONAL DAM INSPECTION PROGRAM

FEBRUARY 1979

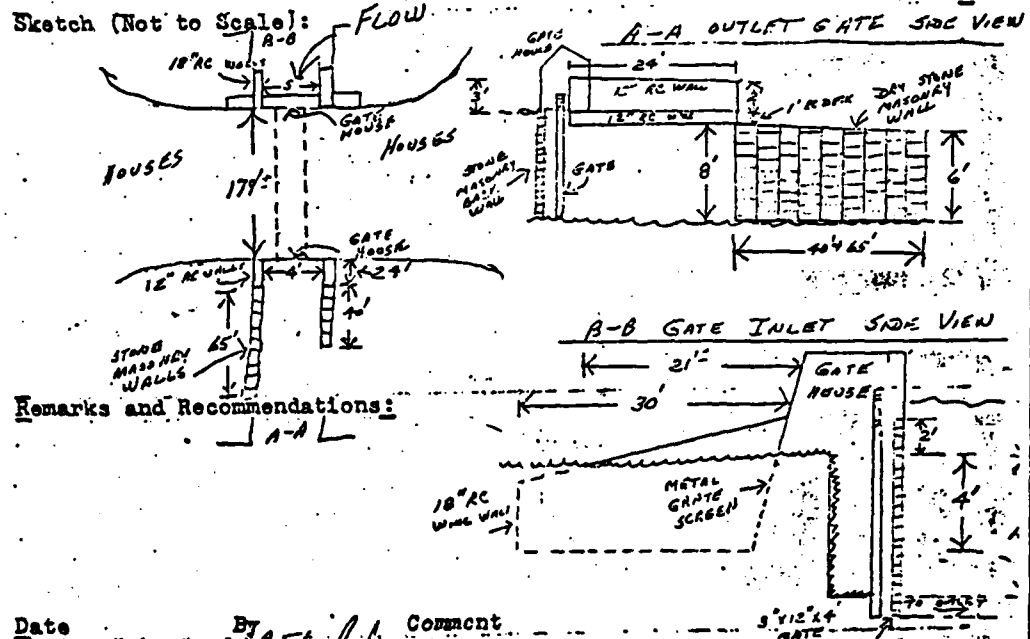
Sketch (Not to Scale):

General Description of Dam and Discharge Control: EARTH-DIKE TO EAST
OF GATE HOUSE. DAM IS 180' IN WIDTH
BETWEEN GATE HOUSES. 3" X 12" X 4" GATE ON INTAKE. TIMBERS ON OUTLET GATE
ROTTED OUT & BROKEN. 30' X 30' DEPRESSION BEHIND INTAKE GATE HOUSE.

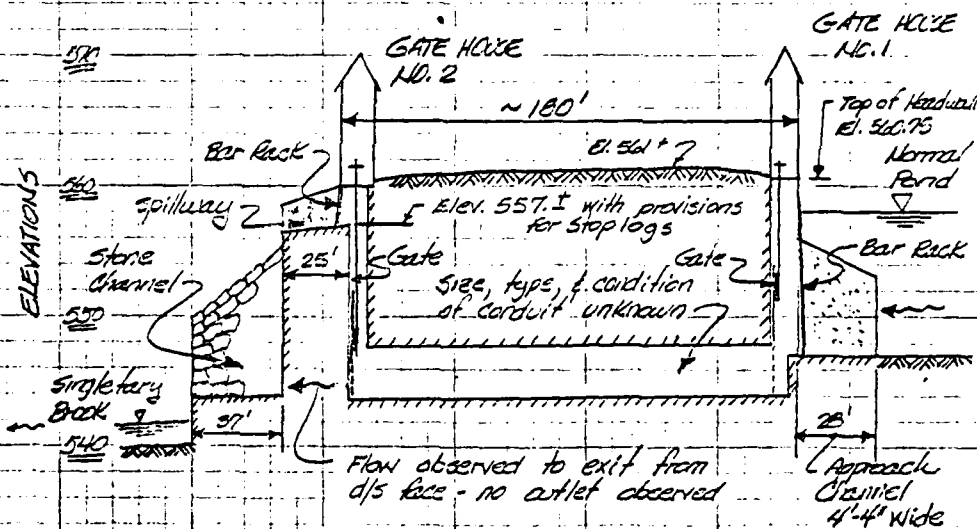
OUTLET WORKS: The following sketch is based on field survey & field inspection. Details within & between gate houses are assumed as interiors were inaccessible.

Normal pond level is controlled by stoplogs in gate house #2. Flow discharges over stoplogs and down spillway which is a 4 ft. wide (arg.) by 3 ft. high x 25 ft. long concrete channel. Crest elev. w/o stoplogs is about 557.0. At the end of the 25 ft. long spillway the discharge drops approx. 13 ft. into a stone channel which is 37 ft. long by 4 ft. wide at the ups end and 7'-3" wide at the d/s end. At the end of this

Channel the discharge drops another 2 ft.
into Singlethry Brook

At the time of inspection both gates 1 & 2
were open (exact open unknown) and the
pond was being lowered for the winter.
No discharge was occurring over the
spillway. All flow was exiting from the
downstream face of the spillway through
an unobserved outlet and into the 27 ft.
long stone channel.
